INQUIRY INTO OPERATION BURNHAM

This presentation is authored by David Napier. David is the owner operator of SKYVUW Limited and has been asked to provide his services as an aerial imagery specialist to the Inquiry.

In terms of the brief for my participation in this Inquiry, utilising commercially available satellite imagery, terrain data and scans of the photographs appearing in *Hit & Run*, I have been asked to comment on;

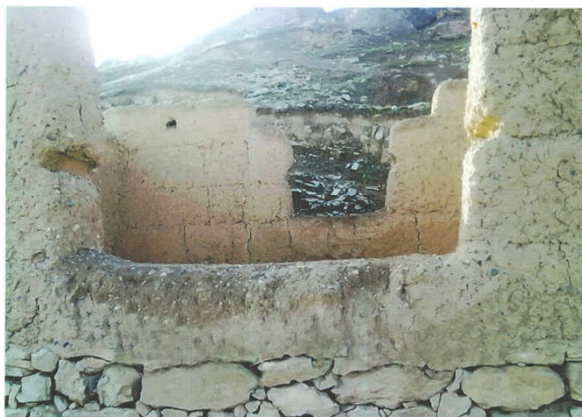
Picture from page 38 of *Hit & Run*

Though cropped differently, photographs 38 and 132 bottom are of exactly the same building. This represents a heavily damaged or neglected building with parts of the rear wall missing and with obviously no roof. As the photograph has been cropped so closely, there is little in the way of geographical features visible to accurately place where this photograph is. There appears to be another building behind this subject, above on the ridge on the sky line but again, there is not enough detail to make a positive identification.

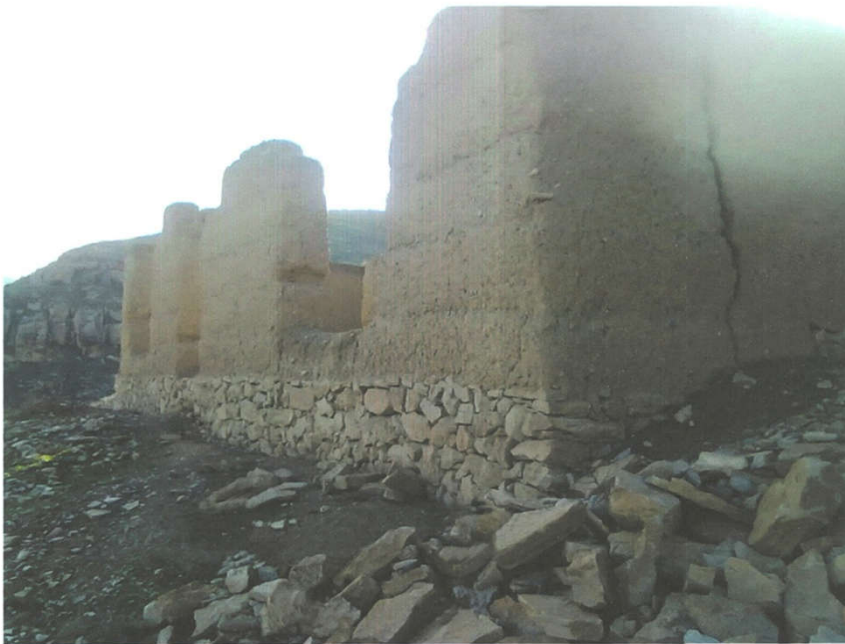
Picture from page 131
(top) of *Hit & Run*

The top image in page 131 purports to show a different building in a different location however, it is the same building as shown in the previous two images.

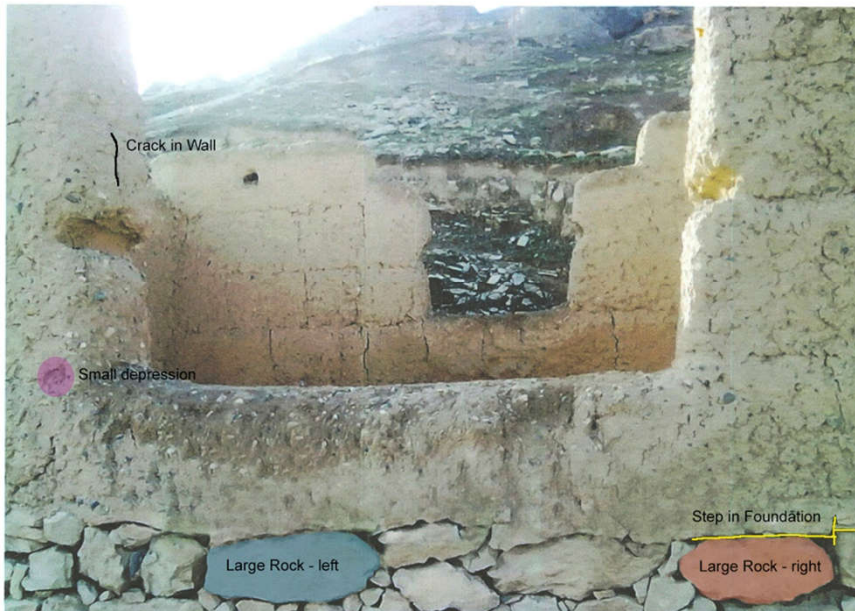
Picture from page 38 of
Hit & Run

With reference to photo 38, I have identified a number of common features that appear on this and photo 131 top. The most obvious of these are two large rocks in the foundation, an unusually shaped crack in the window opening and a distinctive depression in the wall.

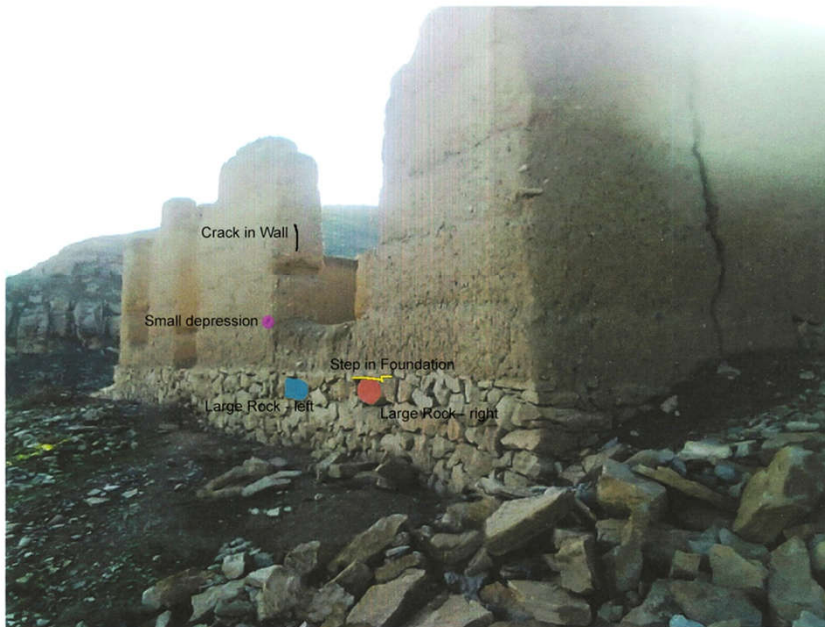
Picture from page 131
(top) of *Hit & Run*

We can now link photos 38, 131 top and 132 bottom to one another.
What interested me further was the large crack appearing on the near end of the building in 131 top.

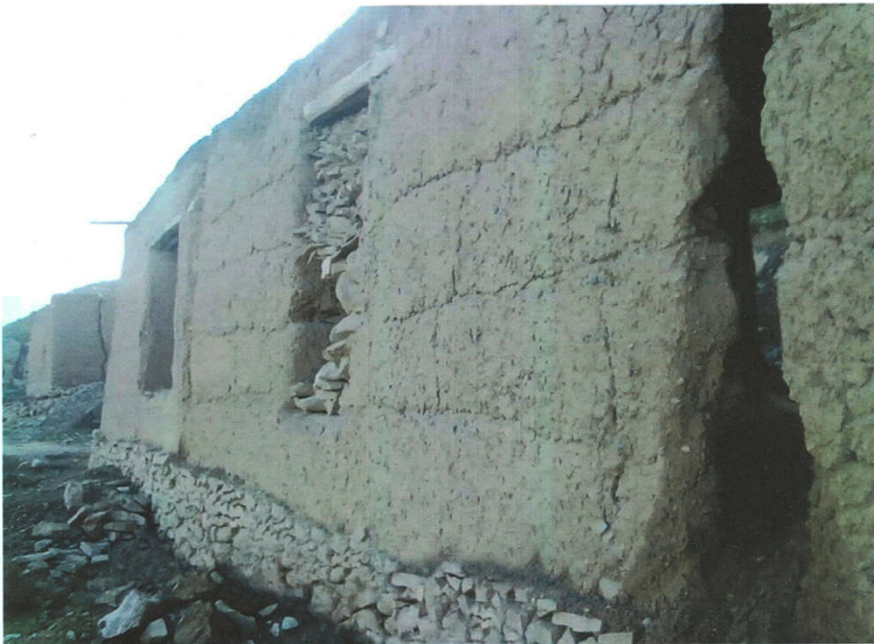
Picture from page 132
(top) of *Hit & Run*

When examining photograph 132 top, I noted that a similar crack appeared in the building in the background.

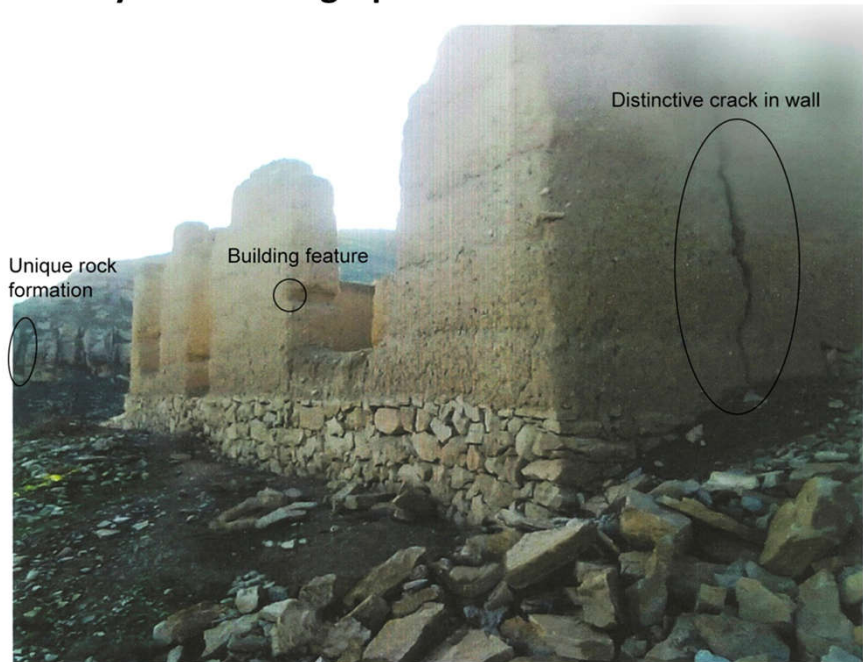
Picture from page 131
(top) of *Hit & Run*

And those same features on photograph 131 top.

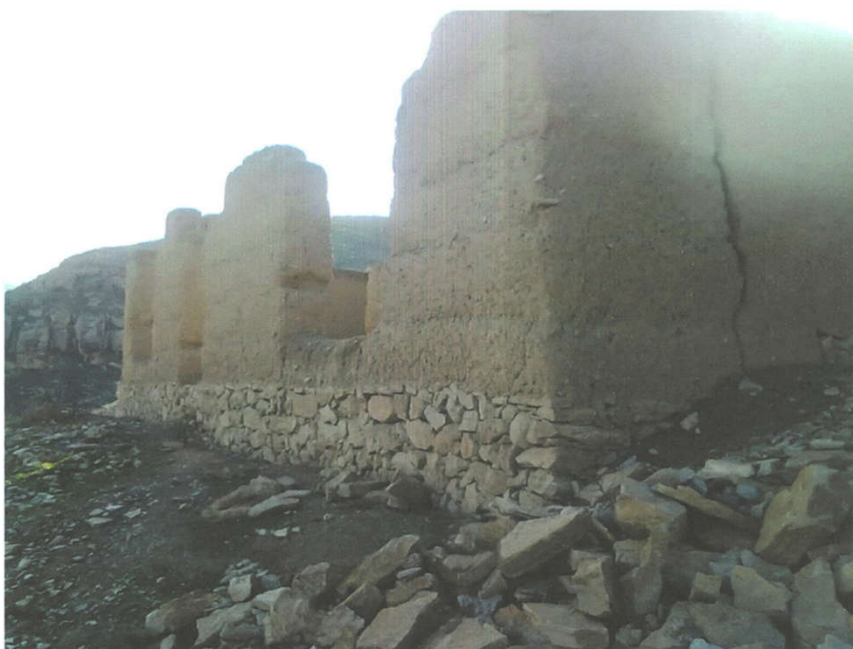
Picture from page 131
(top) of *Hit & Run*

In all the photographs shown, there is a common thread which is the unusual colour of the sand or soil around the buildings. Whereas the predominant colour of the soil in the Operational Area, as defined by the NZDF as a 600m radius about position MGRS 42S VD 23061 91545, is a dun colour, this is definitely black, almost taking on the appearance of black sand.

I have studied the Operational Area in great detail and cannot find a location that shows such ground. Neither am I able to find a grouping of buildings such as these are, particularly when placed against a back drop of such a steep, craggy cliff as appears in the back ground of these images. My only conclusion can be that these two buildings on pages 38/132 bottom and 132 top do not occur within the Operational Area. Where they may be however, is not clear.

With regard the possibility of “explosive” damage, the walls that remain appear to be strong and bare no indications of having had explosives of any sort applied to them. There are no “scorch” marks nor is there evidence of any of the walls being “blown in”.

Of note is the absence of any “sharp corners” on any of the breaches. This would indicate a degree of weathering, making them rounded and relatively smooth. I

am not a specialist on this type of erosion but would assume that weathering of this sort would take some time further suggesting that these buildings have been in this state of disrepair for many years.

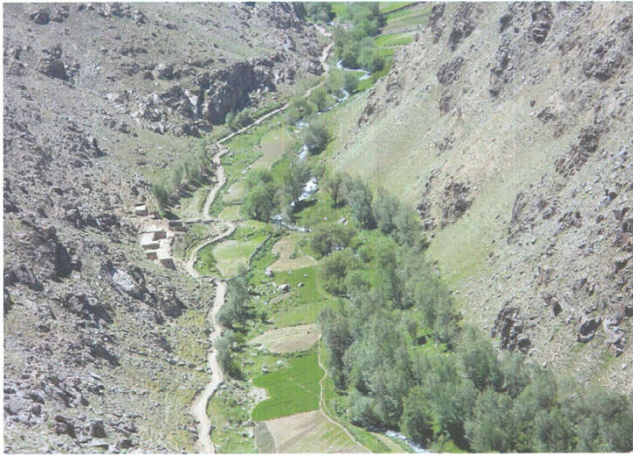
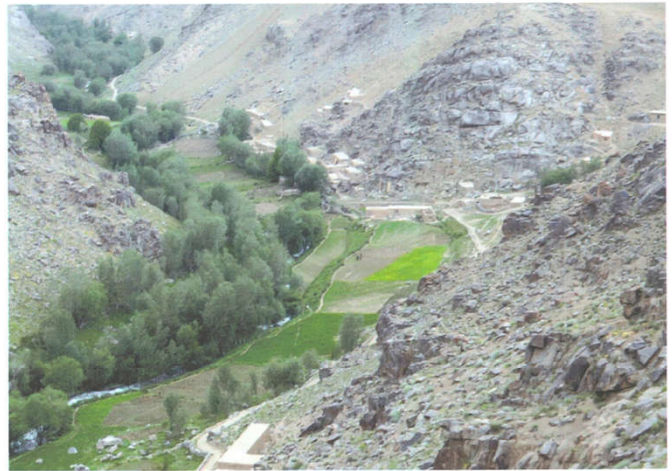
Location of Building A3

Hit & Run
Page 39

Hit & Run
Page 60

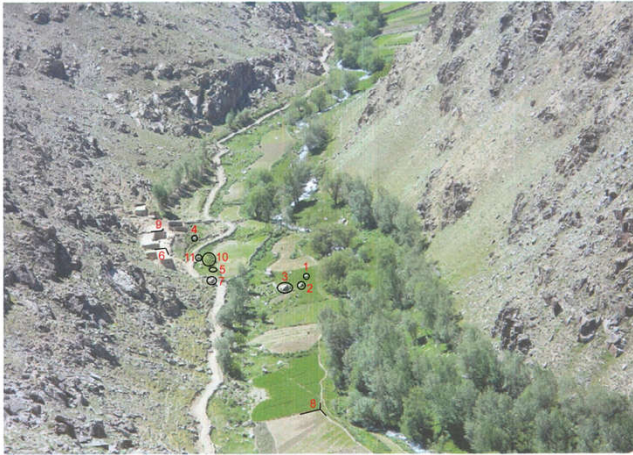
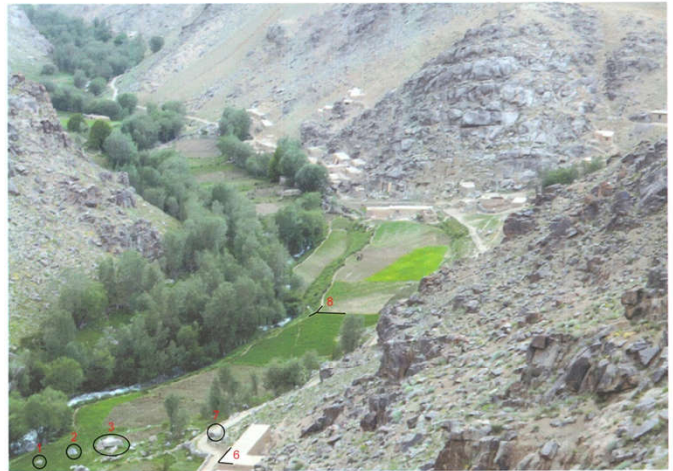
Location of Building A3

Hit & Run
Page 39

Hit & Run
Page 60

The common features from both images were readily identified on satellite imagery as shown. Of note is that the common feature “6”, the corner of a building that appears on the images in *Hit & Run*, is missing from the satellite image. This shows that the building was not there as of 26th December 2011 and no foundation evidence can be seen on the satellite imagery. This disproves the assertion in the caption for photograph 39 that this building was burnt down and subsequently rebuilt. Satellite imagery shows that the building was not there as late as October 2014 but did appear in images captured in February 2017. Therefore, it appears that this building was constructed sometime between October 2014 and February 2017.

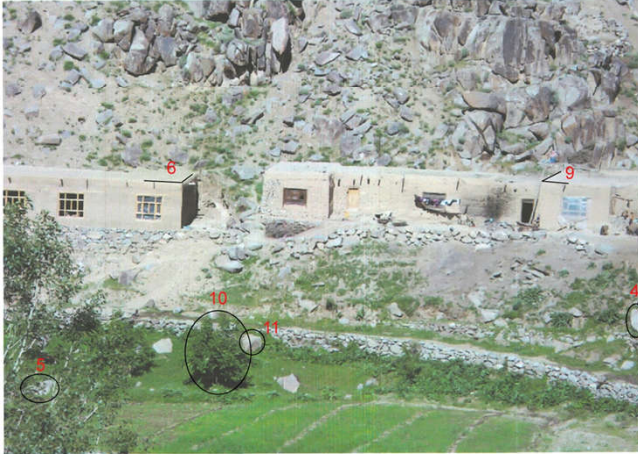
Location of Building A3

Hit & Run
Page 53

With reference to the photo on page 53 of *Hit & Run*, utilising the common features identified on photo's 39 and 60, many of these same features can be found on photo 53. Mr Hager's suggestion is totally correct that the buildings to the right of the photo are indeed A3 with the new building on the left.

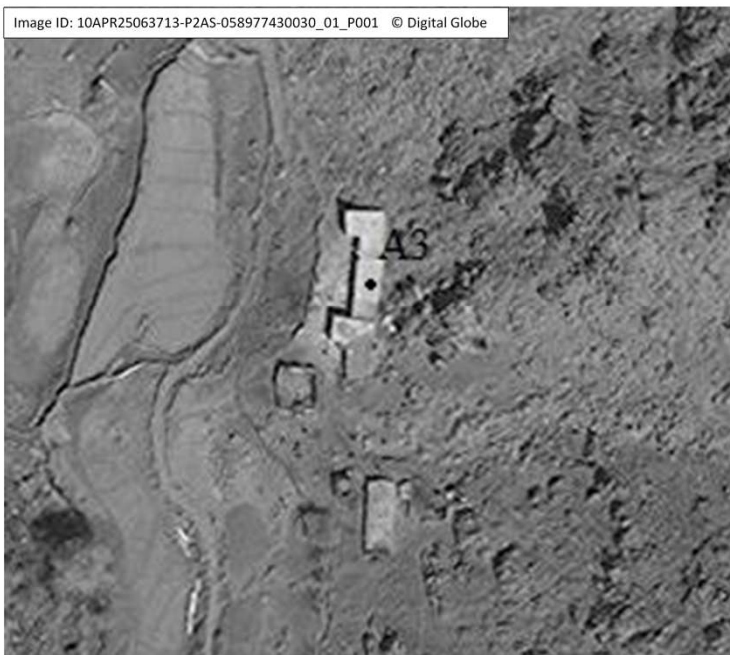
Part of a 0.5m GSD image captured by World View 1 on 25th April 2010

With regard visible damage to the building at A3, due to the fact that satellite imagery is vertical, any analysis must rely on damage to the roof of buildings and any other indicators that could point to damage having been recently repaired. This slide shows the small group of buildings taken on 25th April 2010, before Operation Burnham.

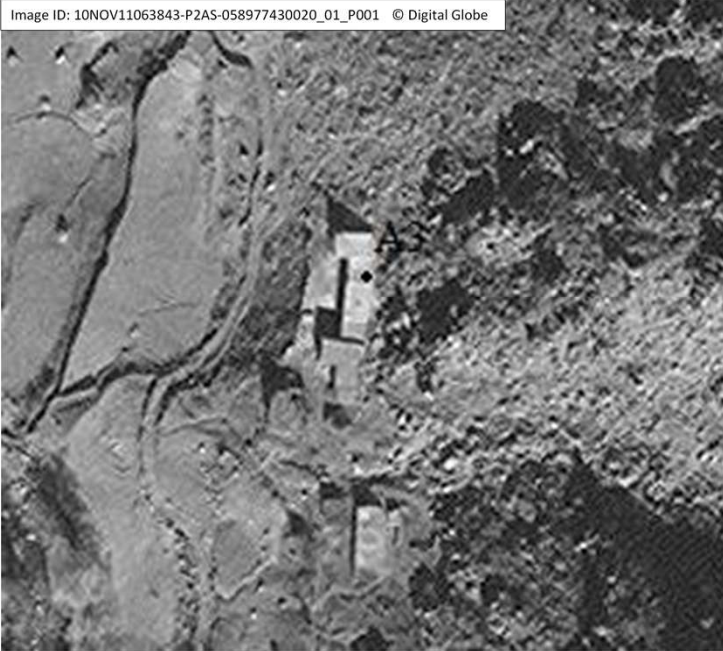
Part of a 0.5m GSD image
captured by World View 1
on 11th November 2010

This slide shows the same group taken on 11th November 2010, 81 days after Operation Burnham. There is no visible damage to the roof however, there are certainly different nuances on the roof colour on the southern of the two buildings which could indicate repairs or similar.

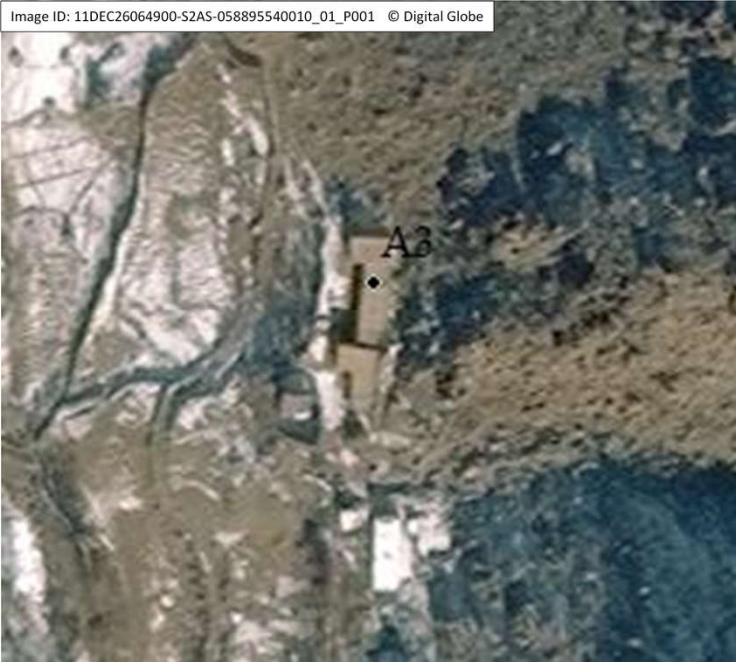
Part of a 0.5m GSD image
captured by World View 2
on 26th December 2011

NZDF have indicated that an “explosive entry method” was utilised to enter the building and that an internal fire was started probably due to a cooking fire getting out of control. If that is the case, the damage must have been minor or completely repaired as evidenced by the satellite imagery which shows an intact roof structure.

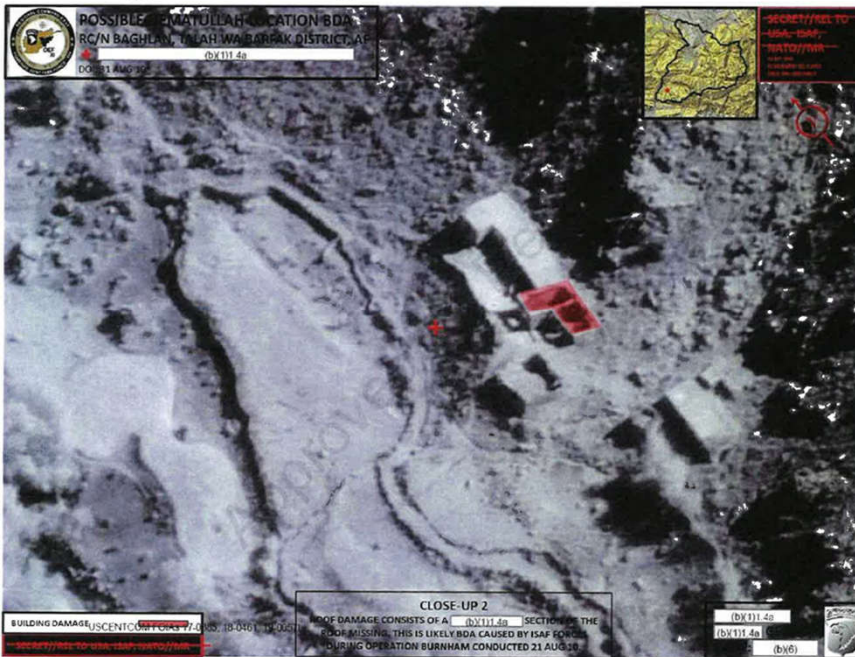
Page 79 of the AR15-6 report showing BDA on 31st August 2010

This slide however clarifies a number of things. This shows a Battle Damage Assessment (BDA) of the group of buildings from the recently released US Army Report AR15-6 with the imagery dated 31st August 2010, just ten days after the raid. This image clearly shows destruction of the roof of the southern-most building of the A3 collective. As has been shown in the previous slides, the building was intact four months before, and was also intact three months after Operation Burnham and one month after Operation Nova, therefore one can only assume that the building was a primary place of residence and with the onset of winter nigh, efforts were made to rapidly repair the structure to make it habitable.

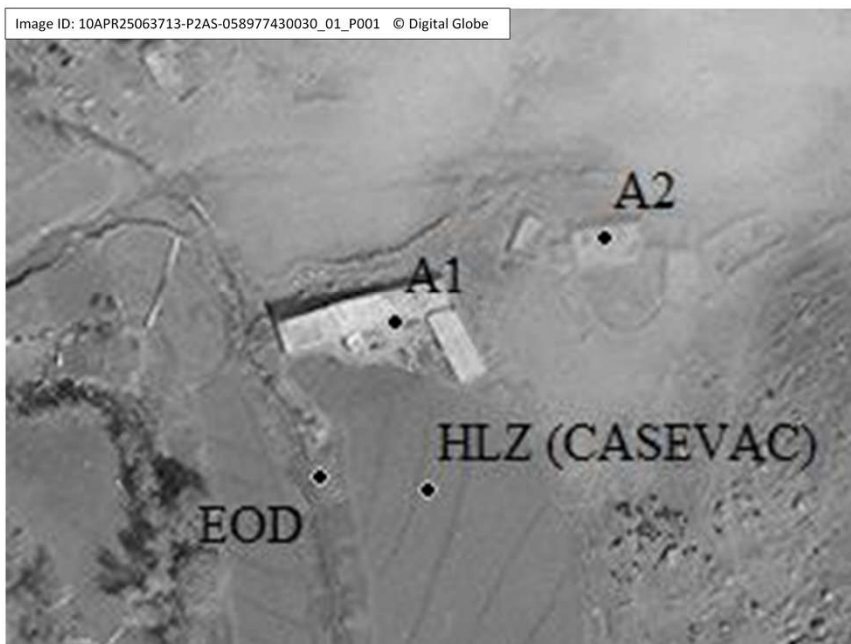
Part of a 0.5m GSD image captured by World View 1 on 25th April 2010

NZDF has admitted that A1 was the most damaged due to the methods of entry as well as the fact that destroyed ordinance fell onto the building creating a fire. Indeed, as is reported in a number of the NZDF documents, a soldier was medevac'd from the scene after a wall and roof fell on him when entering A1. There is agreement by NZDF and Mr Hager, that this building and A2 were owned by Abdullah Kalta – known as Objective Burnham, one of the main targets of the operation.

As can be seen in the image in this slide, taken on 25th April 2010 some four months before Operation Burnham, the two buildings are very close being in fact 21m apart. Both buildings appear to be intact and to all intents and purposes, appear to be well maintained and habitable.

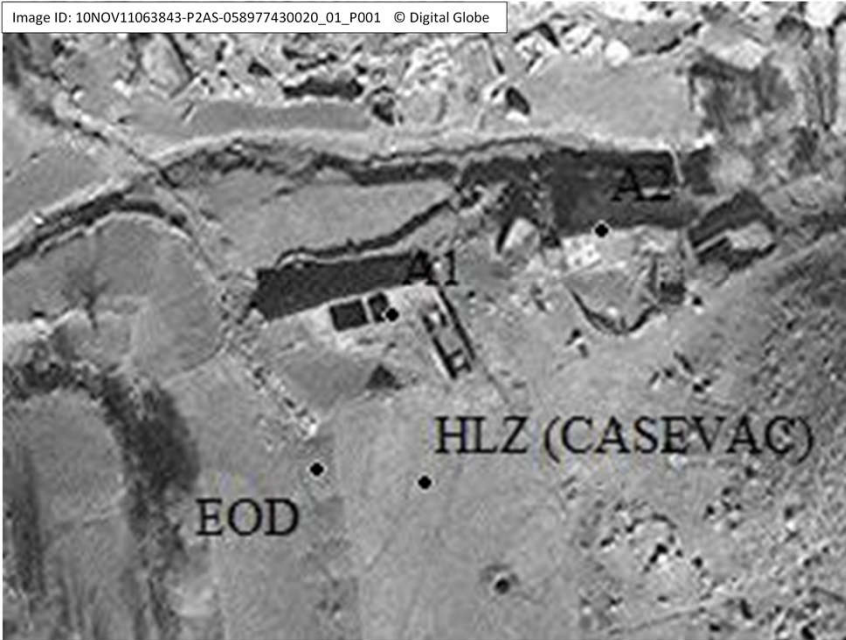
Part of a 0.5m GSD image captured by World View 1 on 11th November 2010

The image in this slide taken on 11th November 2010, 81 days after Operation Burnham and 38 days after Operation Nova, clearly shows there are two large holes in the roof structure of A1. As can be seen by the shadow cast by A1, the holes appear to be in the middle of the building roughly half way along its east/west axis.

Interestingly, in the 4th April 2019 presentation by Colonel Motley, the NZDF report states that the western wall was breached which then collapsed along with the roof, causing the injuries to an SAS member. The satellite image in this slide, as it is in all the slides presented, shows North to the top, meaning the western wall would be the wall at the left-hand end of the building. Though it is not clear from this image whether the western wall has collapsed or not, the satellite image clearly shows that the western end of the building has an intact roof. Moreover, the long shadows cast by the building indicate that the northern wall of the building is also intact as if it wasn't, sunlight would be shining through the gaps. It is difficult to see if the southern wall is intact but it appears to be. One can only assume then the second entry point that was created was probably somewhere along the southern wall. However, the fire that started in A1 as a result of the ordinance disposal could have precipitated the collapse of the roof as shown.

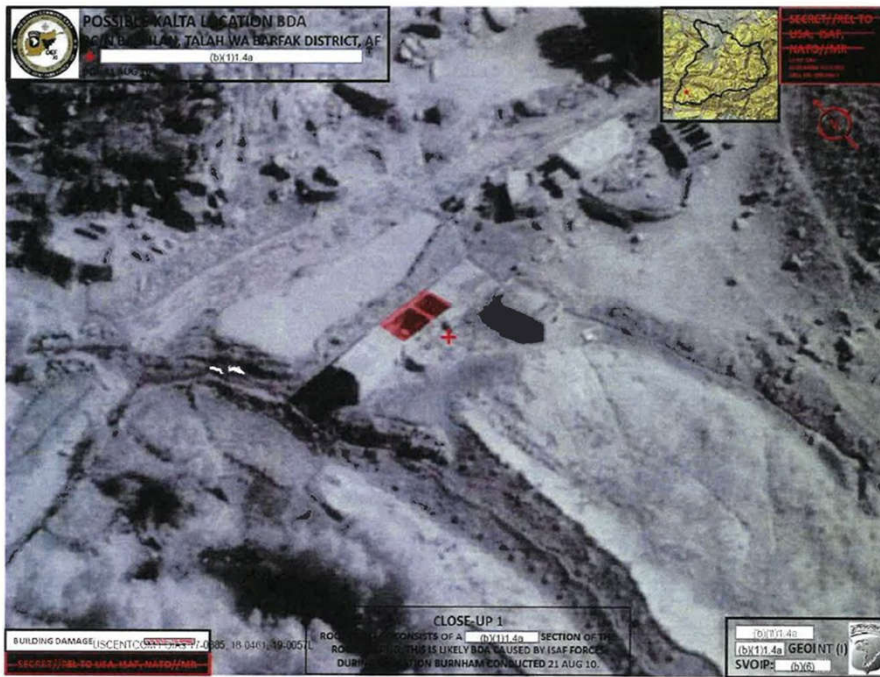
Page 81 of the AR15-6 report showing BDA on 31st August 2010

This slide shows page 81 of the material released by the United States under the Freedom of Information Act, which is a Battle Damage Assessment image taken on 31st August 2010. Whilst the heavy shadow cast by the western end of the building makes any damage impossible to see, there appears to be a breach in the southern wall immediately beside the red cross. Whether this was a doorway or a blown entry is unable to be determined however, there is a hole in the wall aligning with the damaged roof. This damage appears to be the same as that shown on the 11th November 2010 satellite image in the previous slide, implying that no further visible damage occurred between those dates. This refutes the assertion by My Hager on pages 80 and 81 of *Hit & Run* that the building was “destroyed” by Operation Nova on 3rd October 2010, 38 days before the previous satellite image was captured.

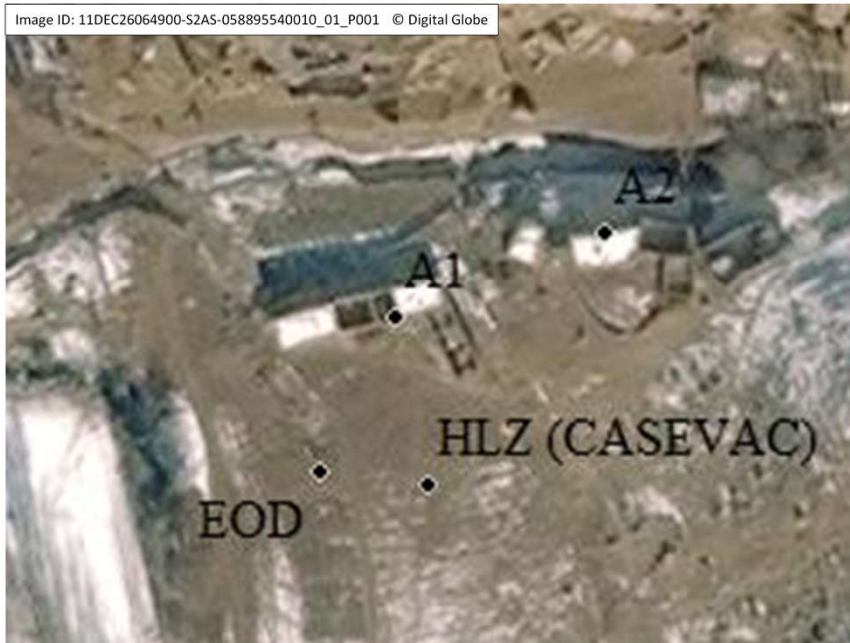
Part of a 0.5m GSD image
captured by World View 2
on 26th December 2011

The colour image from 26th December 2011 clearly shows a solid snow cover of the remaining roof of A1 and the whole of A2. Given my previous comment regarding heat escaping through the uninsulated roof and melting the snow on habited buildings, I can only conclude that these two buildings were uninhabited as at the end of 2011. Indeed, the fact that the roof has not been repaired, definitely leads one to that opinion.

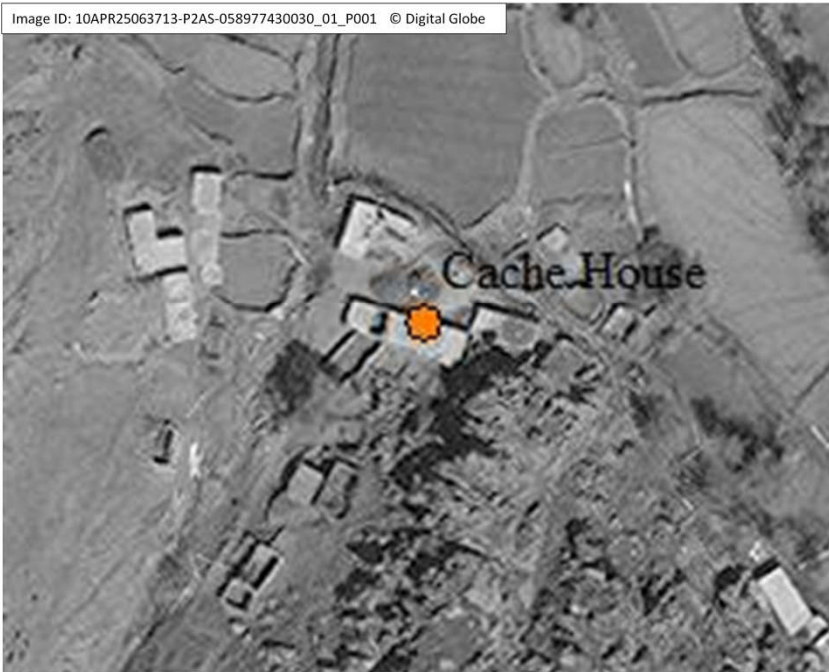
Part of a 0.5m GSD image
captured by World View 1
on 25th April 2010

The current slide shows the Cache House before Operation Burnham which shows a neat and intact building. The image is from 25th April 2010.

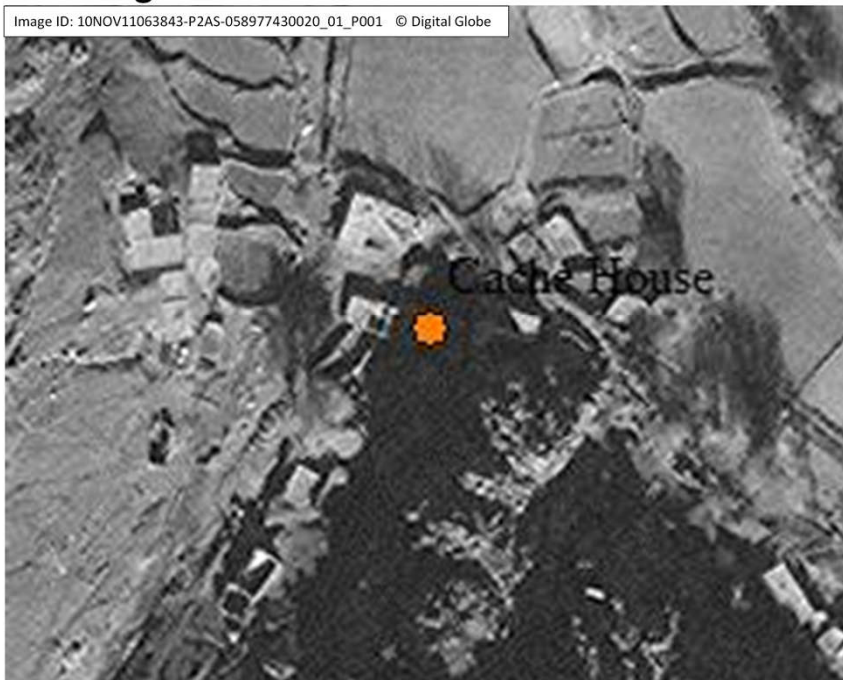
Part of a 0.5m GSD image
captured by World View 1
on 11th November 2010

Unfortunately, the low sun angle evident in this image taken on 11th November 2010, 81 days after Operation Burnham, means that the majority of the building is in deep shadow. Having carefully viewed this image in a number of viewing packages, my opinion is that it doesn't appear, from this imagery, that there is any major damage to this building. However, as has already been shown by the damage and repair to A3, whatever damage that may have occurred may have already been repaired.

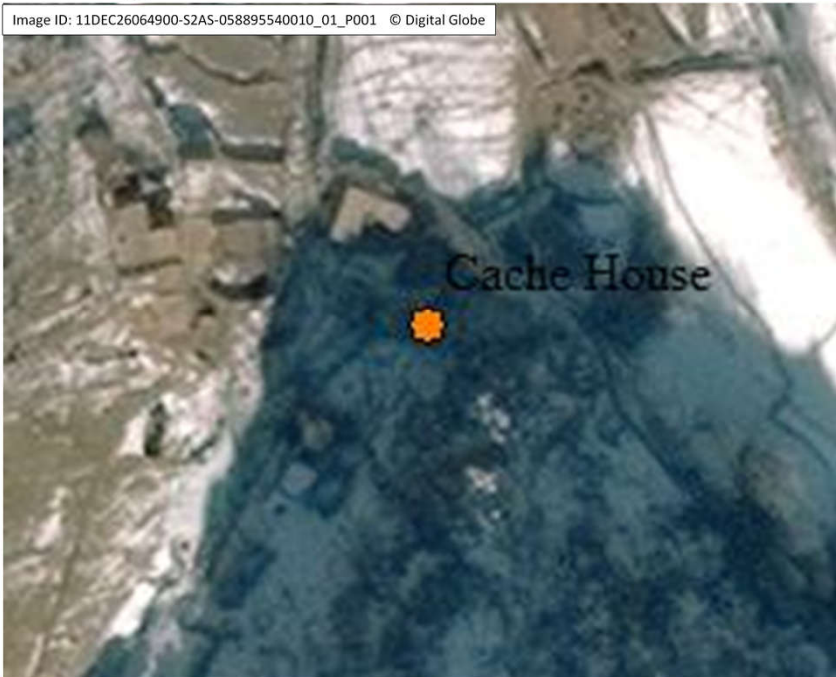
Image ID: 11DEC26064900-SZAS-058895540010_01_P001 © Digital Globe

Damage to Cache House

Part of a 0.5m GSD image
captured by World View 2
on 26th December 2011

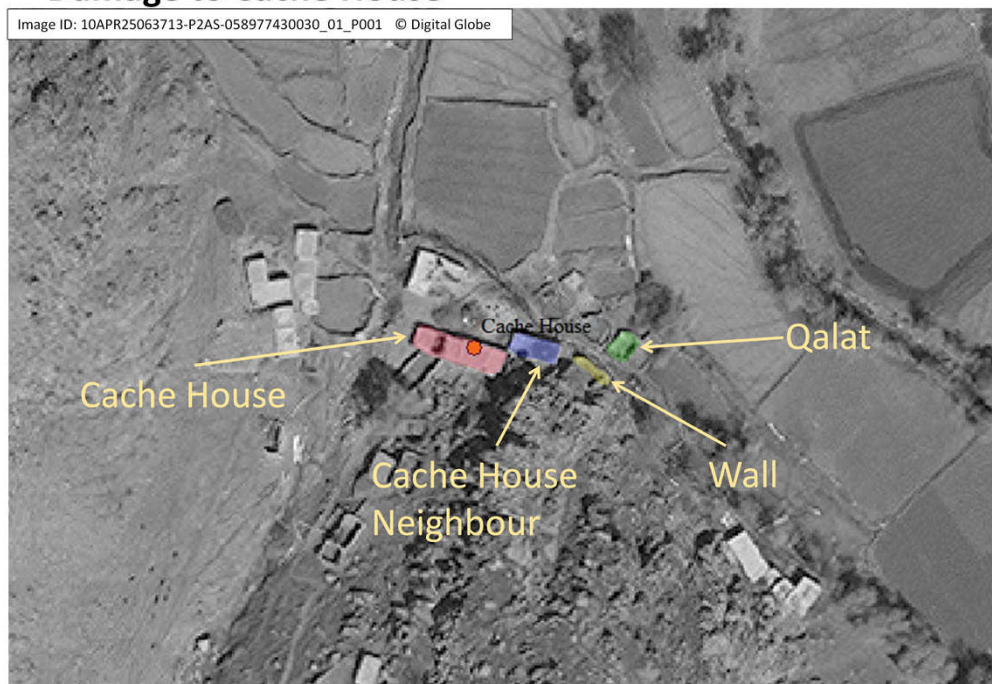
Image ID: 10APR25063713-P2AS-058977430030_01_P001 © Digital Globe

Damage to Cache House

For reference, here is an enlargement of a satellite image of that area with four distinct physical features identified.
